Homan House Restoration Update

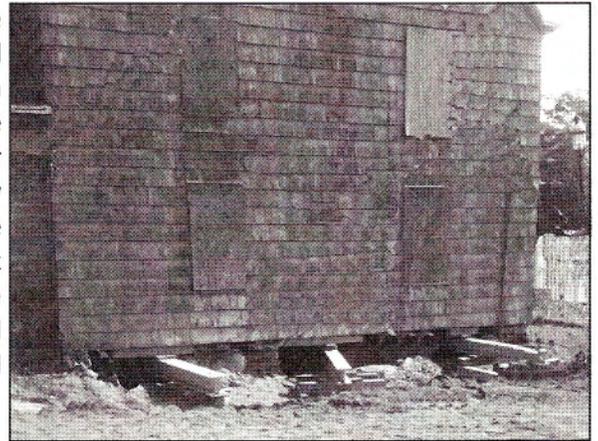
In a crucial first step, steel beams were inserted through the foundation to support the structure.

An appropriate technique for stabilizing the House to ensure safety and durability is the first crucial step in the actual construction phase. For the main portion of the House, a decision has been made to insert several steel beams through holes in the foundation to support the structure. Work has begun on this. For the back portion of the House, the House will be raised very slightly to allow repairs to be made to the stone work. Once repairs are completed, the back portion of the House will be lowered back down to its “original” position. Further stabilization work will be required to repair the chimney (support from beneath and throughout the House) before the House can be considered completely safe for interior work to begin.
